**SITE ASSESSMENT REPORT
FOR
WEST ROOSEVELT DRUM SITE
CHICAGO, COOK COUNTY, ILLINOIS
TDD NO.: T05-9501-006
PAN: EIL0856SAA**

February 17, 1995

**Prepared for:
UNITED STATES ENVIRONMENTAL PROTECTION AGENCY
Emergency and Enforcement Response Branch
77 West Jackson Boulevard
Chicago, Illinois 60604**

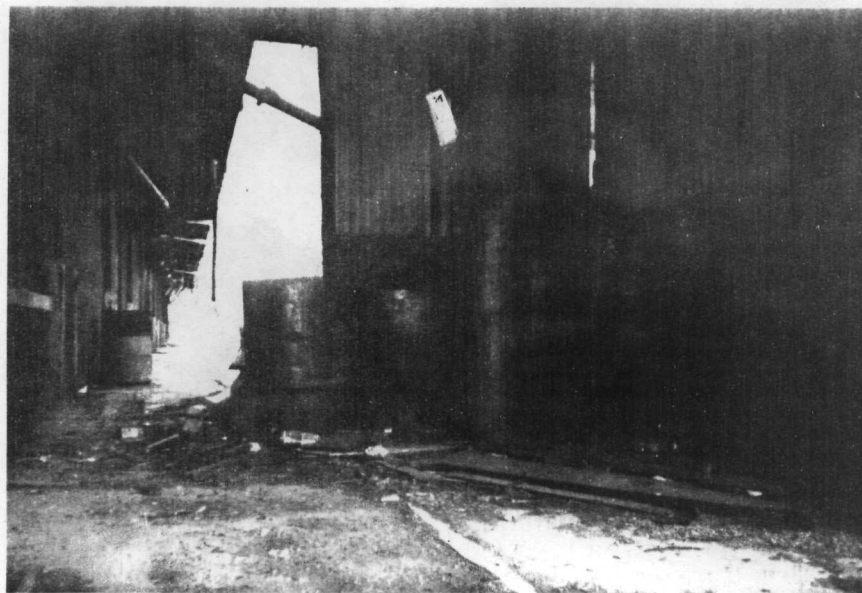
SITE: WEST ROOSEVELT DRUM SITE
 TDD#: T05-9501-006 PHOTOGRAPHER: Ramaly
 DIR: N DATE: 01/27/95 TIME: 0920
 DESCR: Drums and compressed gas
 cylinders at loading dock near
 southeast corner of site.

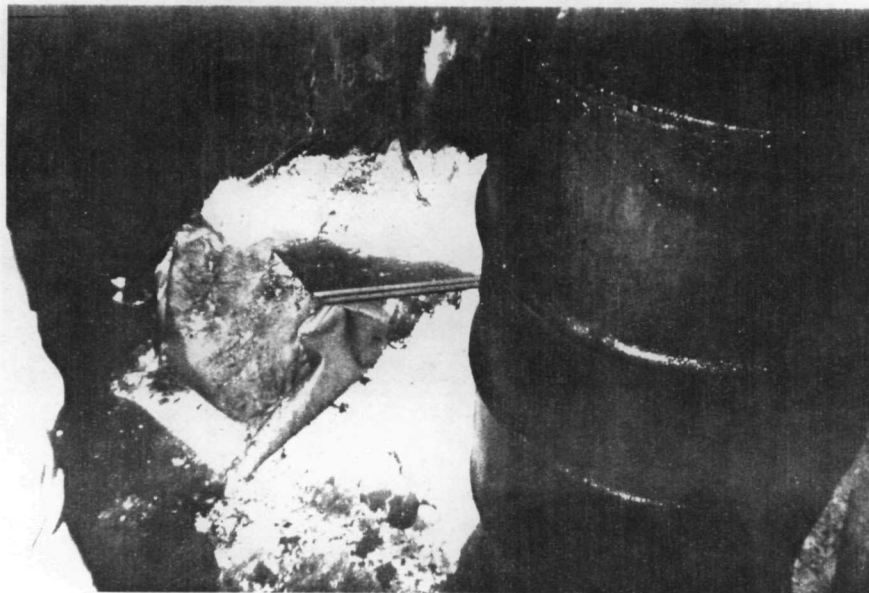
SITE: WEST ROOSEVELT DRUM SITE
TDD#: T05-9501-006 PHOTOGRAPHER: Skare
DIR: N/A DATE: 01/27/95 TIME: 0945
DESCR: Food processing products along
west wall of main room.

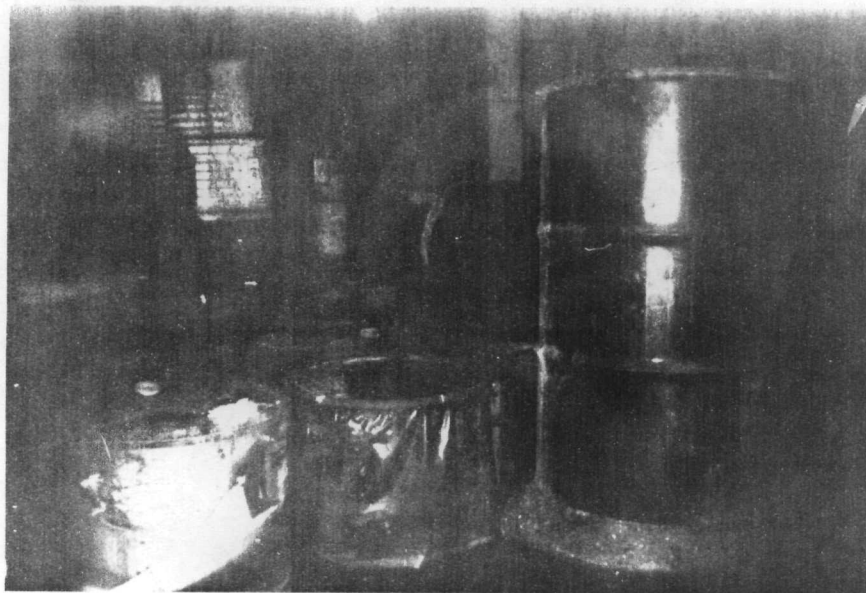
SITE: WEST ROOSEVELT DRUM SITE
 TDD#: T05-9501-006 PHOTOGRAPHER: Skare
 DIR: N DATE: 01/27/95 TIME: 1000
 DESCR: Drums stacked along north
 extension of main room.

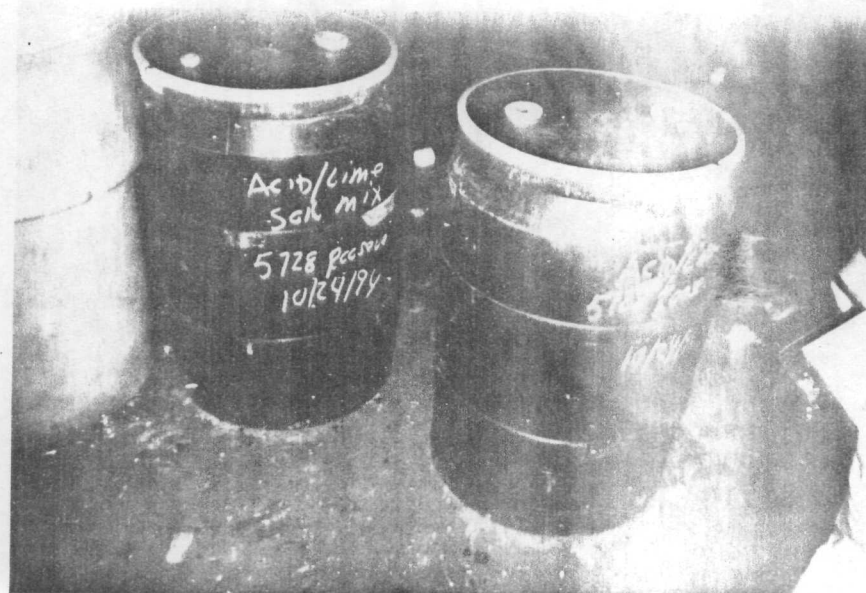
SITE: WEST ROOSEVELT DRUM SITE
 TDD#: T05-9501-006 PHOTOGRAPHER: Skare
 DIR: E DATE: 01/27/95 TIME: 0950
 DESCR: Overpacked thioglycolic acid
 drum by RES. Two drums of
 contaminated debris from spill.

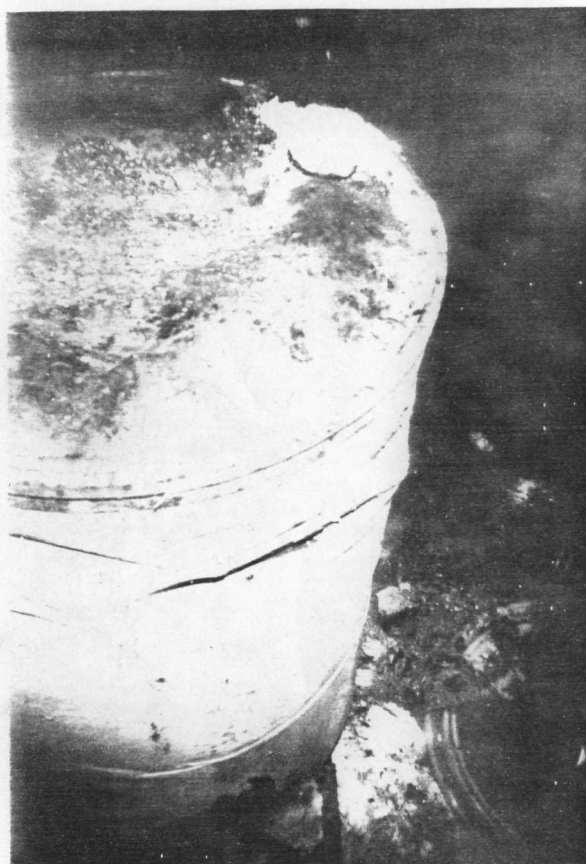
SITE: WEST ROOSEVELT DRUM SITE
TDD#: T05-9501-006 PHOTOGRAPHER: Skare
DIR: N/A DATE: 01/27/95 TIME: 1000
DESCR: Drum labeled corrosive w/inor-
ganic salt exuding at bung, NW
corner main room, sample D-2.

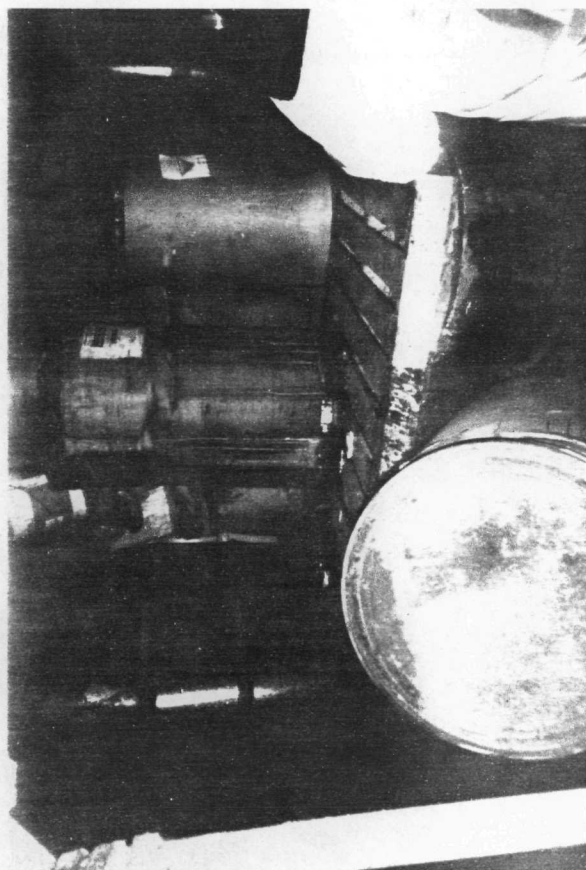
SITE: WEST ROOSEVELT DRUM SITE
TDD#: T05-9501-006 PHOTOGRAPHER: Skare
DIR: N DATE: 01/27/95 TIME: 1005
DESCR: Drums stacked along north wall
of main room, NE corner. Note
leaks and 'corrosive' label.

Many of the containers of proven or potentially hazardous materials were in poor condition, leaking, or stacked in an unsafe manner. Long-term storage of these materials at the site could result in a release.

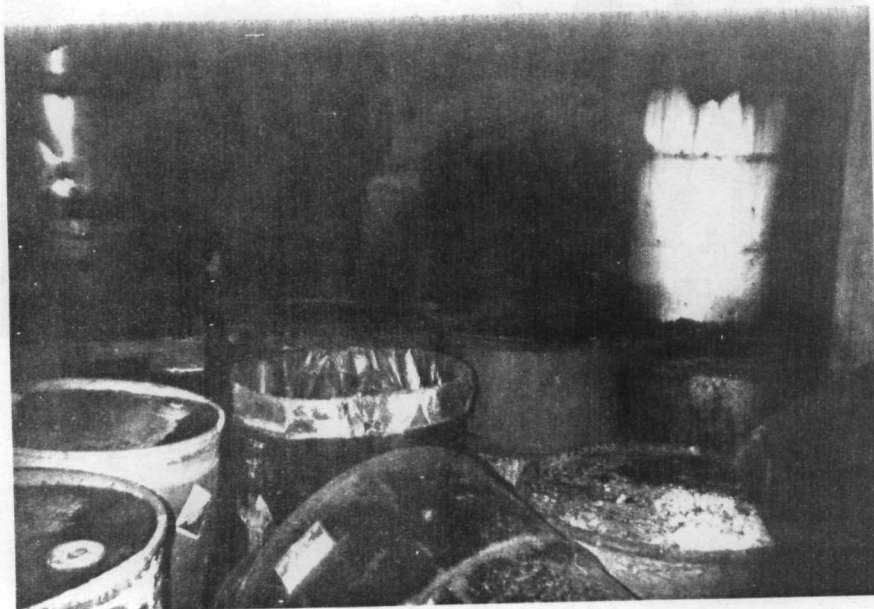
SITE: WEST ROOSEVELT DRUM SITE
 TDD#: T05-9501-006 PHOTOGRAPHER: Skare
 DIR: N DATE: 01/27/95 TIME: 1010
 DESCR: Drums, some labeled 'corrosive'
 near NE corner of main room.
 Sample D-3 from blue/yellow drum

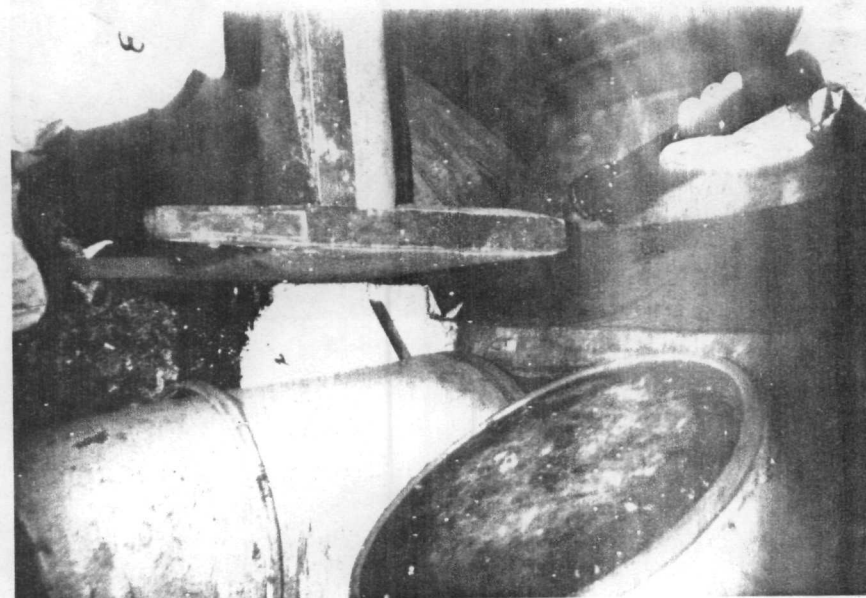
SITE: WEST ROOSEVELT DRUM SITE
 TDD#: T05-9501-006 PHOTOGRAPHER: Skare
 DIR: N/A DATE: 01/27/95 TIME: 1006
 DESCR: Spilled white flakes near NE
 corner of main room. Sample D-6
 collected of white flakes.

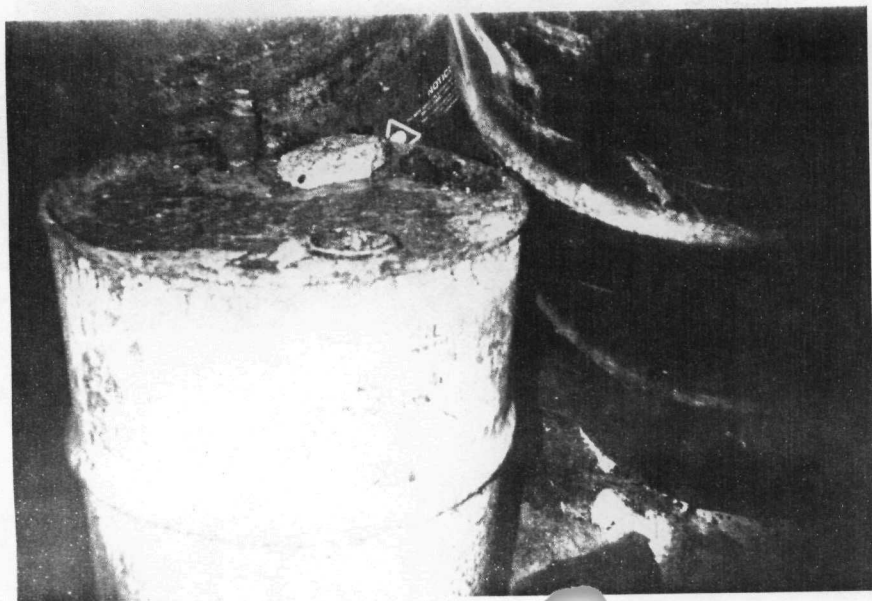
SITE: WEST ROOSEVELT DRUM SITE
TDD#: T05-9501-006 PHOTOGRAPHER: Skare
DIR: N/A DATE: 01/27/95 TIME: 1015
DESCR: Sample D-3 location, northeast
corner, main room.

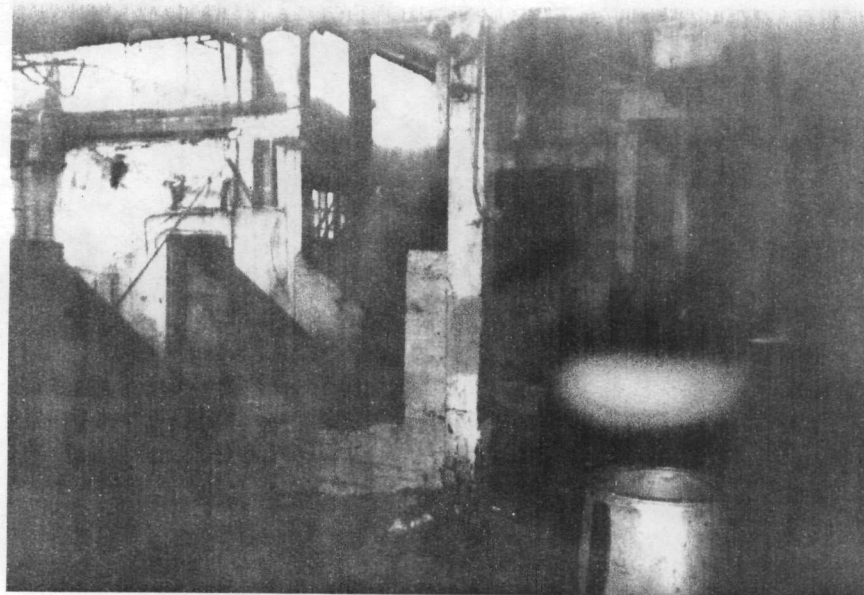
SITE: WEST ROOSEVELT DRUM SITE
TDD#: T05-9501-006 PHOTOGRAPHER: Skare
DIR: N DATE: 01/27/95 TIME: 104
DESCR: Previous location of a vessel
located along west wall of main
room.

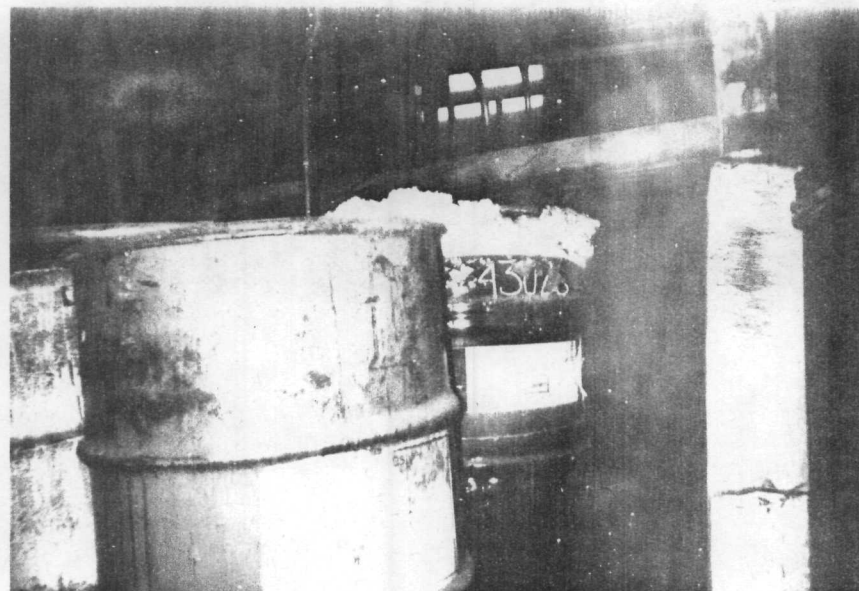
SITE: WEST ROOSEVELT DRUM SITE
TDD#: T05-9501-006 PHOTOGRAPHER: Skare
DIR: E DATE: 01/27/95 TIME: 1030
DESCR: Drum on right (black w/crystal)
sampled as D-5; in center of
main room.

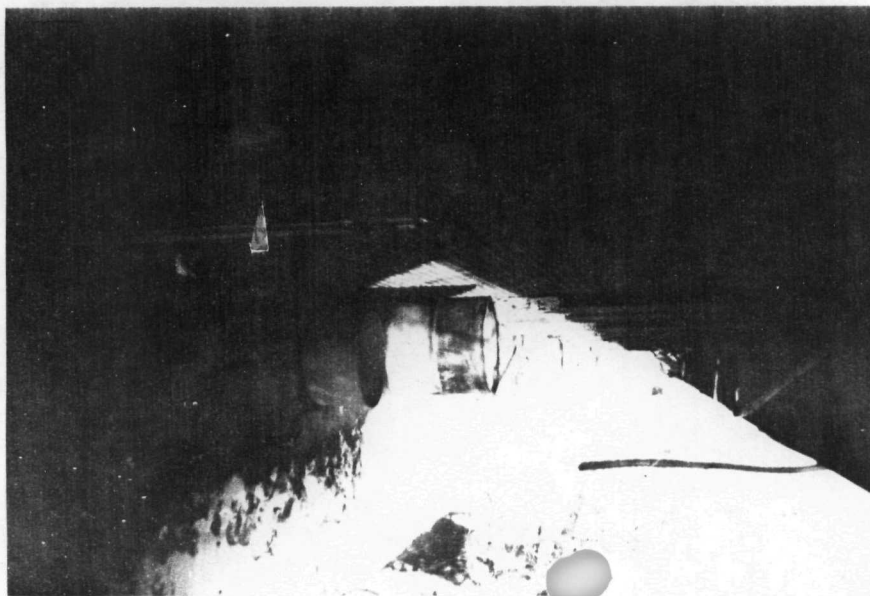
SITE: WEST ROOSEVELT DRUM SITE
TDD#: T05-9501-006 PHOTOGRAPHER: Gebien
DIR: E DATE: 01/27/95 TIME: 1130
DESCR: Drums and compressed gas
cylinders on loading dock.

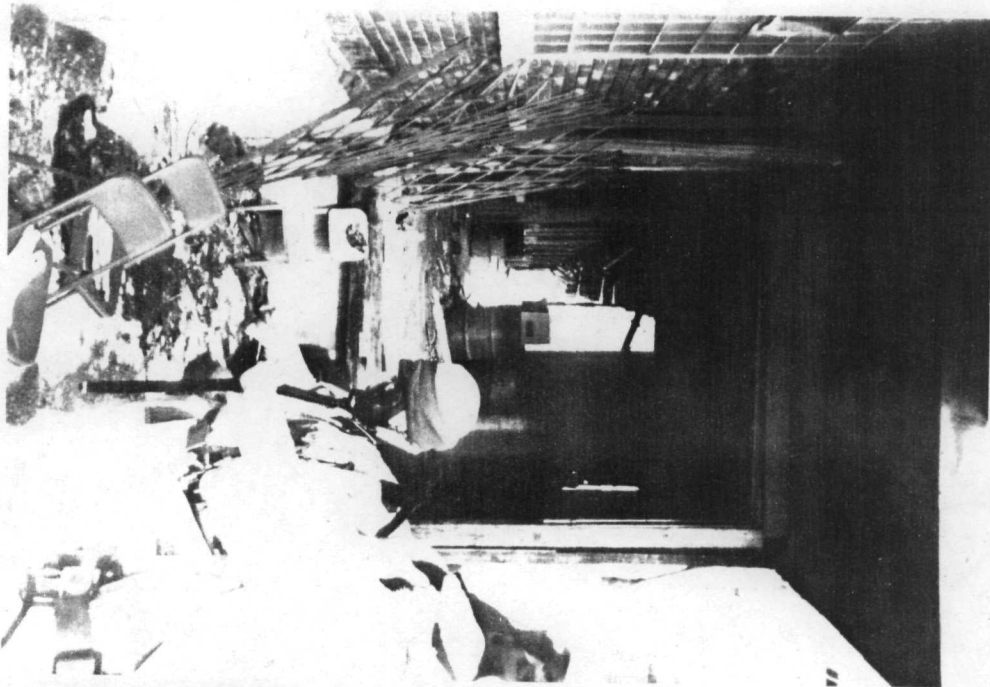
SITE: WEST ROOSEVELT DRUM SITE
TDD#: T05-9501-006 PHOTOGRAPHER: Skare
DIR: S DATE: 01/27/95 TIME: 1136
DESCR: Two drums in the otherwise
empty rear building.
